August 1, 2024

MIR-24-22

Contact of Towing Vessel *John 3:16* with Pier

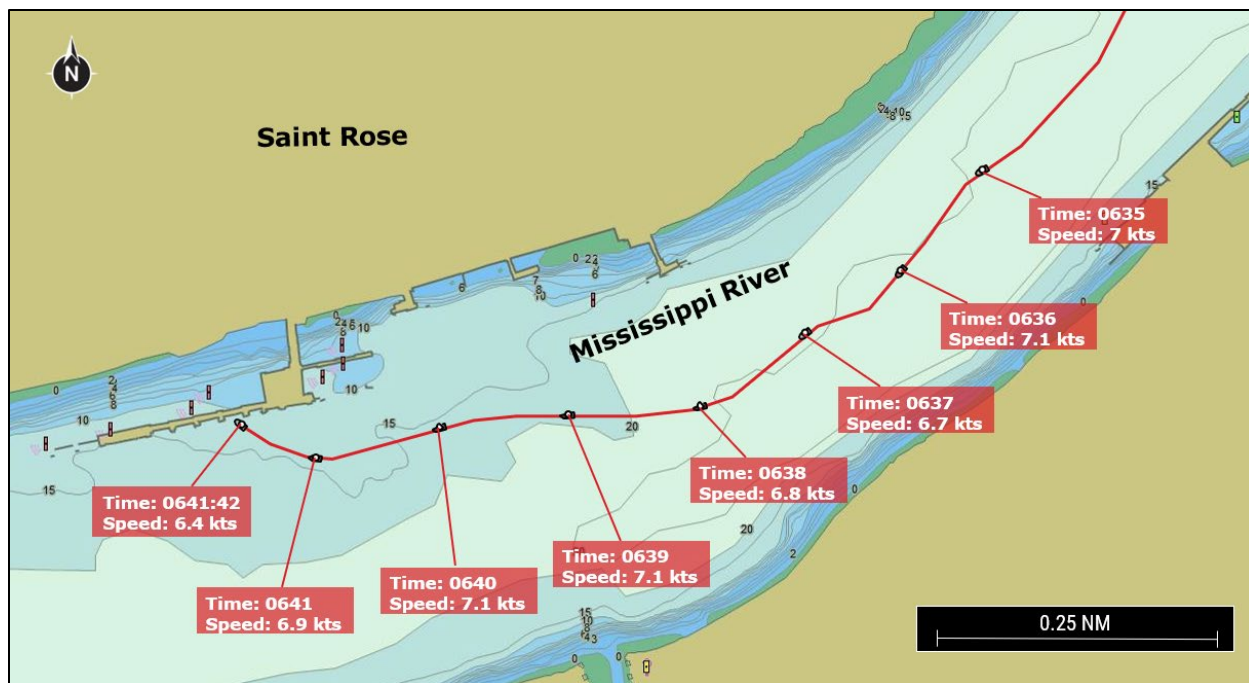
The pilot told investigators that the last thing that he remembered before the contact was passing another towing vessel, the *Okaloosa*, at 0636. At 0640, the *John 3:16* was transiting at 7 knots near mile 118 when AIS data and the towing vessel's electronic chart system playback showed the vessel begin to turn to starboard toward an industrial cargo pier. The vessel continued its starboard turn toward the pier, and, at 06:41:42, the *John 3:16* contacted the pier at 6 knots, damaging the starboard side of the vessel's wheelhouse (see figure 3).

Figure 3. Trackline of the *John 3:16* before the contact. (Background source: National Oceanic and Atmospheric Administration Electronic Navigation Chart US5LU8AH as viewed on Made Smart)

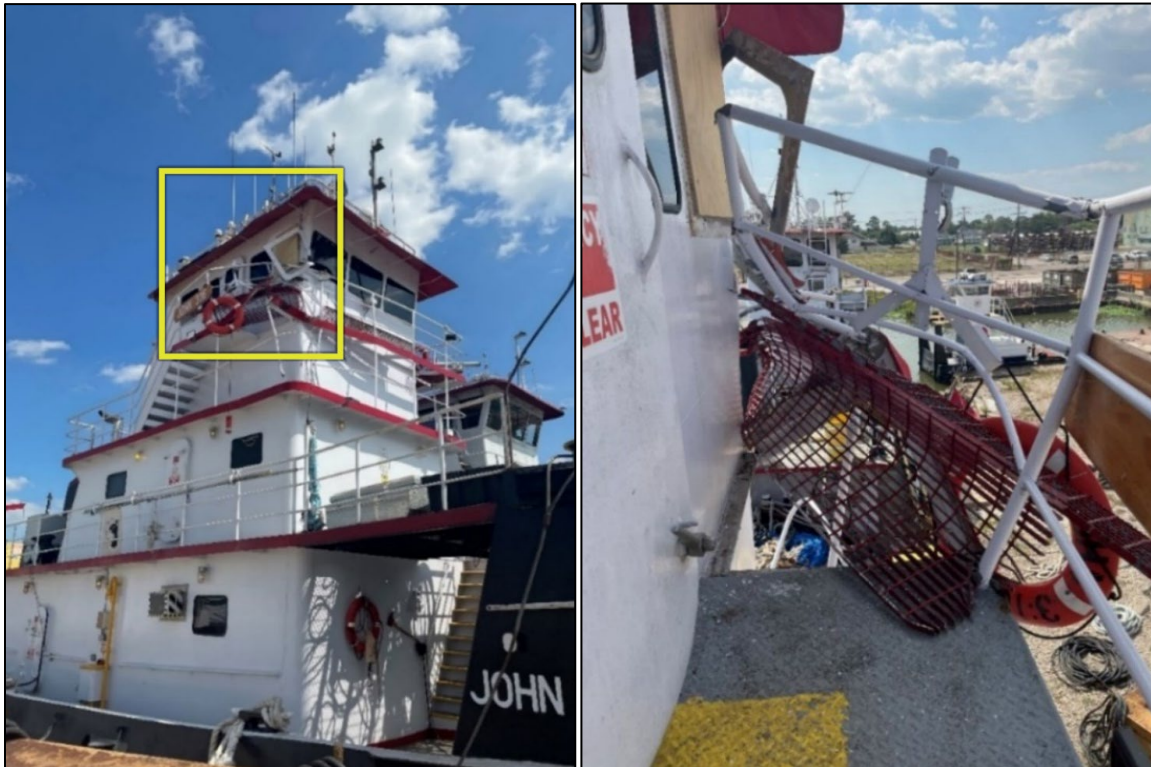
The wheelhouse sustained damage to the framing, windows, exterior railing, and exposed deck on the starboard side (see figure 4). Due to the height of the pier above the waterline, the *John 3:16* sustained no damage below the wheelhouse. The final estimate to repair the damage to the towing vessel was \$89,000.

Figure 4. Left to right: Damage to the *John 3:16* wheelhouse structure (indicated by the square) and damage to the exterior deck and railing on the starboard side of the wheelhouse.

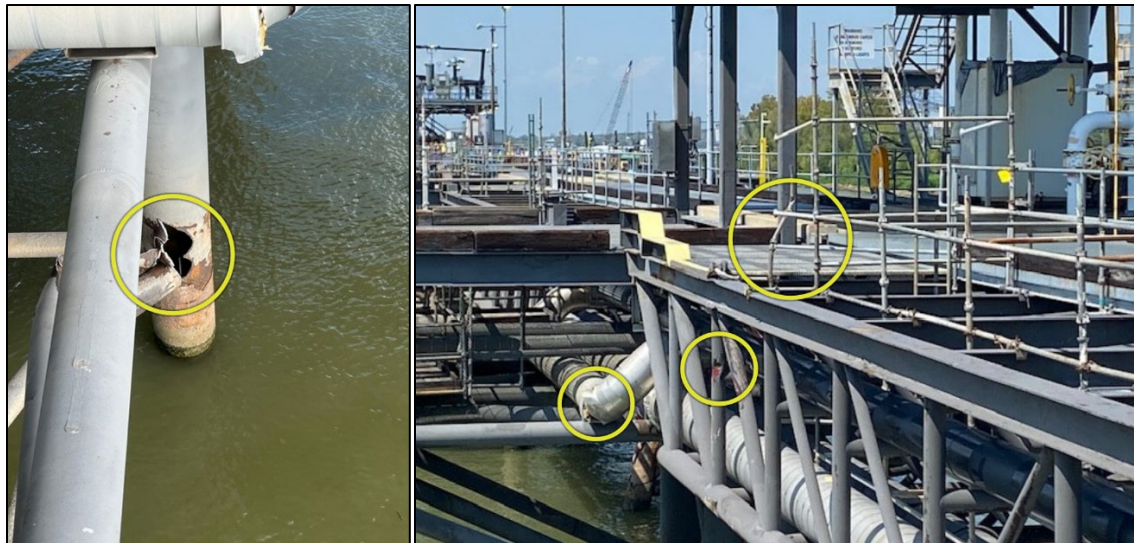
Engineers from the company that owned the pier noted damages to a main vertical piling, pier support bracings, railings, and an insulated pipe that ran along the pier (see figure 5). The final cost to repair the pier was \$196,441.

Figure 5. Left to right: Damage to a vertical piling and insulated pipe, pier support bracings, and railing (indicated by the circles). (Source: Coast Guard)
