August 1, 2024

MIR-24-22

Contact of Towing Vessel *John 3:16* with Pier

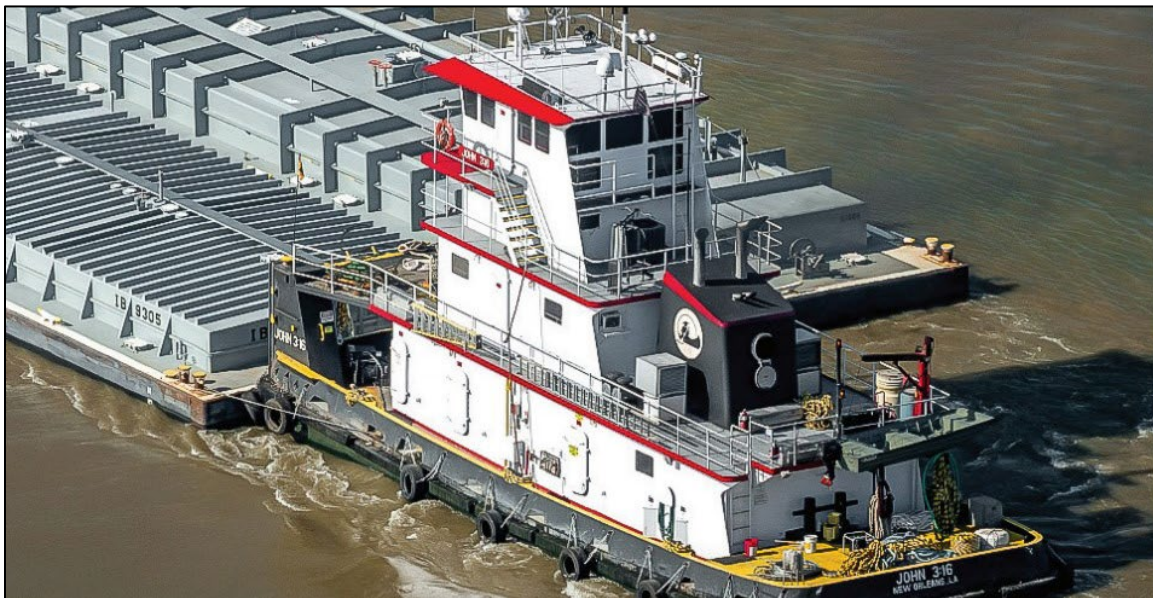
Figure 1. *John 3:16* underway on an unknown date before the contact. (Source: Marquette Transportation)

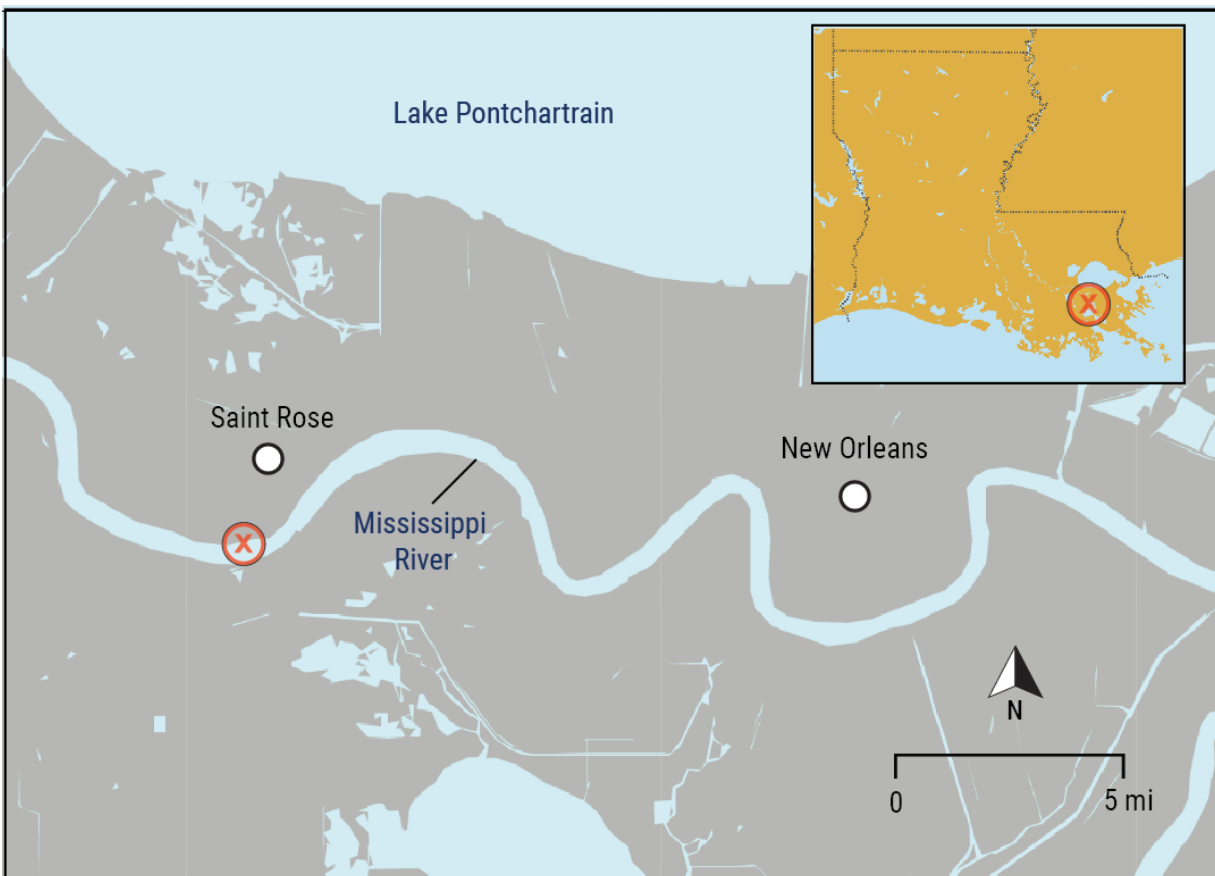
Figure 2. Area where the *John 3:16* contacted the industrial cargo pier, as indicated by a circled X. (Background source: Google Maps)
